Manhole Inspection Summary

Manhole # S19QQ_004MH

Insp Date: **7/10/07 9:42 AM**

Location Address: **1701 GWYNNS FALLS PKWY** Cross Street: **WOOBROOK AVE**

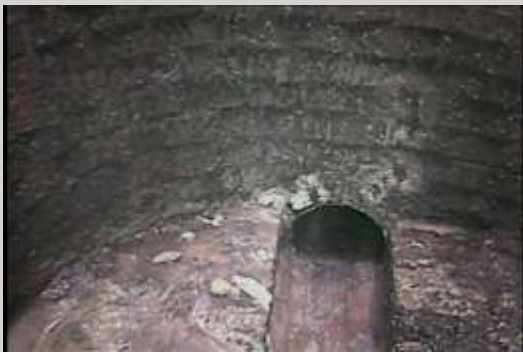
12 O'Clock Outflow

8 in. Circular Gravity Sewer
Pipe Out @ 12 O'Clock

Pipe Height: **8.4** (in.) Rod and Bar (Angled)
Pipe Material: **Clay** ☐ Pipe Lined
Invert Depth: **10.94** (ft.) Flow Characteristics: **Fast**
Deposits: ☒ None ☐ Mud ☐ Sludge ☐ **Debris** ☐ Grease
Silt Depth: (in.) Deposits Extent:
Infiltration: **None** Pipe Seal Cond: **Sound**
